6 5/8RD-ABS-BC

SECTION A-A
BASE COVER CROSS SECTION DETAIL VIEW

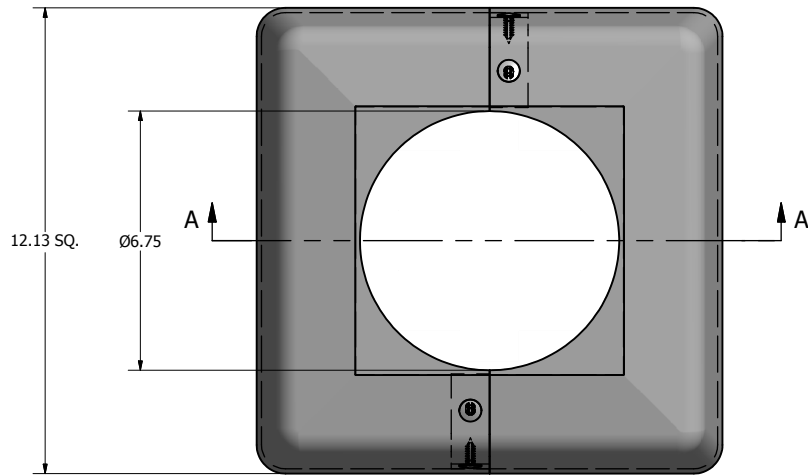
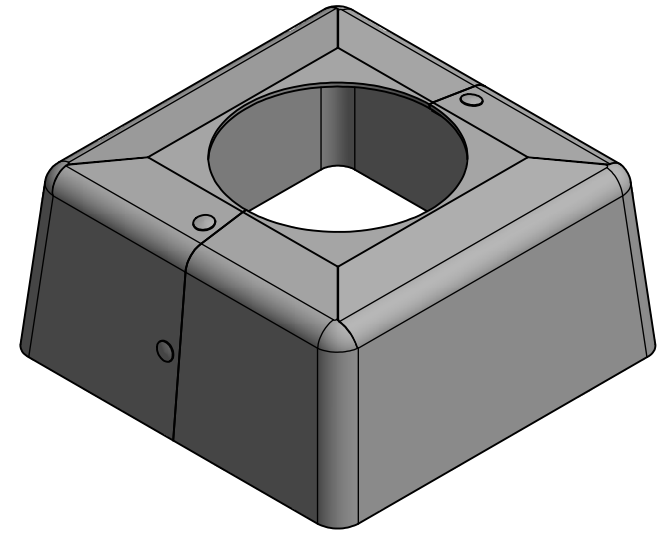
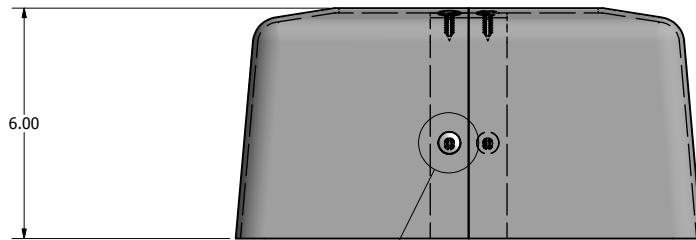
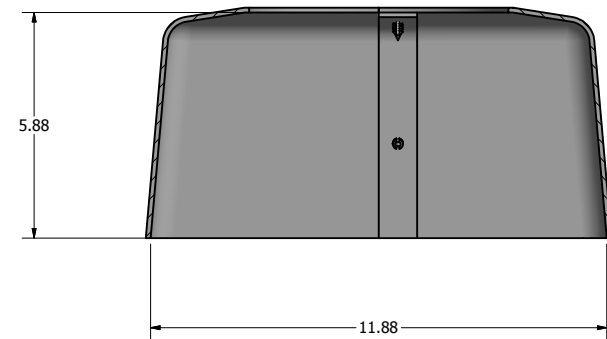
BASE COVER FASTENED TOGETHER WITH 4 PUSH PINS.
